**Flood Control Project Maintenance
Levee Inspections**

Maintenance Issue Types Only, Levee Inspection Report By Mile - Fall 2016

Reclamation District No. 1001 Nicolaus

Waterway	Bank	Unit Miles	Inspection Start/End	Inspector
Unit No. 01 Yankee Slough	Right	4.12	09/20/2016 09/20/2016	Sterling York

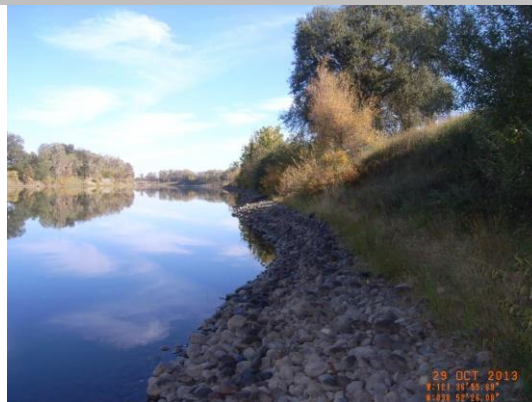
Photo 1 of 1 : FA_2016_RD1001_38_2_20160906_00002.jpg

LM Start	5.80	Rating **	M	Issue No.	2
LM End	5.93	Issue Type +	Ma	Location *	WS
Category	Supplemental			GPS Latitude/Longitude	
				Start	End
Item	2015 USACE Erosion Survey, DRAFT			38.874113 °	38.872373 °
				-121.615380 °	-121.616504 °
DWR ID	DWR_RD1001_04_s_2016_2				
Comment Code					
Inspector Comment					
2011 - Erosion pockets from tree popouts. Sections of the lower bank have slumped off. 2013 - Scallops from tree popouts no longer visible on site. Minor new erosion at the middle of the bank. 2015: Fresh erosion from human use. [2015 Site ID: FHR_6-6_L]

USACE 2013 Photo #1

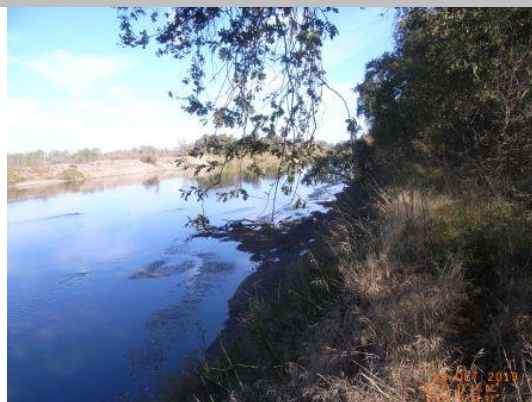
Photo 1 of 1 : FA_2016_RD1001_38_5_20160906_00005.jpg

LM Start	6.42	Rating **	M	Issue No.	5
LM End	6.51	Issue Type +	Ma	Location *	WS
Category	Supplemental			GPS Latitude/Longitude	
				Start	End
Item	2015 USACE Erosion Survey, DRAFT			38.865875 °	38.864706 °
				-121.619983 °	-121.620813 °
DWR ID	DWR_RD1001_04_s_2016_5				
Comment Code					
Inspector Comment					
2011 - Tall slumping sections. Scour around trees has exposed most of the roots. 2015: Recent large slope failure observed. [2015 Site ID: FHR_6-0_L]

USACE 2013 Photo #1

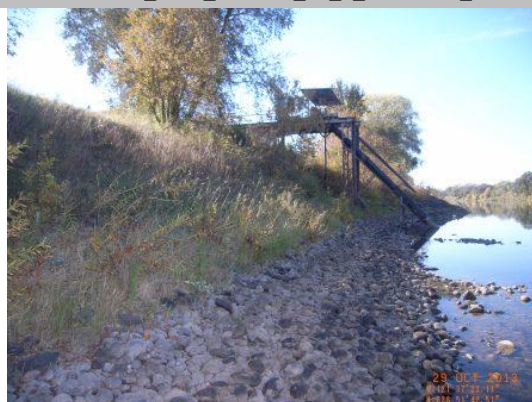
Photo 1 of 1 : FA_2016_RD1001_38_4_20160906_00004.jpg

LM Start	6.57	Rating **	M	Issue No.	4
LM End	6.77	Issue Type +	Ma	Location *	WS
Category	Supplemental			GPS Latitude/Longitude	
				Start	End
Item	2015 USACE Erosion Survey, DRAFT			38.863946 °	38.861558 °
				-121.621388 °	-121.623316 °
DWR ID	DWR_RD1001_04_s_2016_4				
Comment Code					
Inspector Comment					
2011 - Large slumped sections on the lower bank. 2012 - New cracks observed. 2015: No observed changes. [2015 Site ID: FHR_5-8_L]

USACE 2013 Photo #1

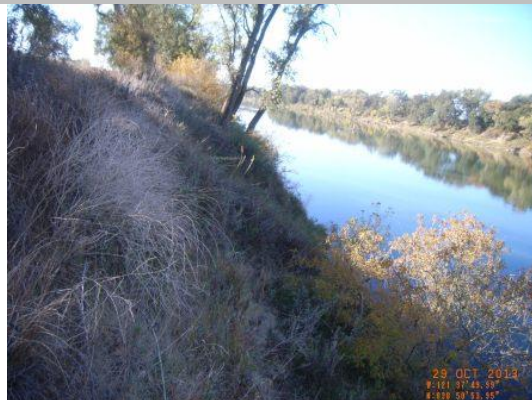
Photo 1 of 1 : FA_2016_RD1001_38_8_20160906_00008.jpg

LM Start	7.47	Rating **	M	Issue No.	8
LM End	7.79	Issue Type +	Ma	Location *	WS
Category	Supplemental			GPS Latitude/Longitude	
				Start	End
Item	2015 USACE Erosion Survey, DRAFT			38.852394°	38.848004°
				-121.629231°	-121.630873°
DWR ID	DWR_RD1001_04_s_2016_8				
Comment Code					
Inspector Comment					
2000 - Steep bank off berm with some slumps and fallen trees, continued erosion. 2002 - Site lengthened upstream and downstream due to vertical bank along most of the reach. 2010 - Site extended upstream. 2011 - Minimal new erosion. 2012 - Site extended on the upstream end, new tree pop-out, and bank erosion continues to worsen. 2013 - Minor new erosion at the toe and top of bank. 2015: No observed changes. [2015 Site ID: FHR_5-0_L]

USACE 2013 Photo #1

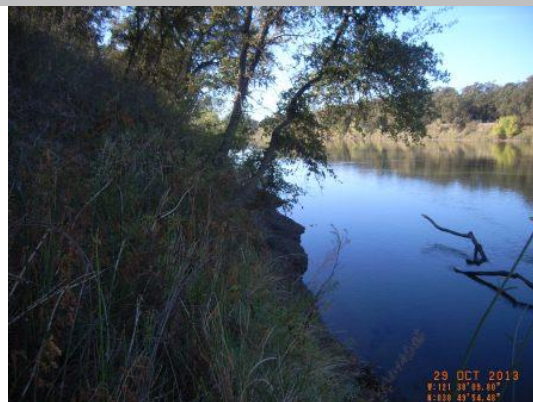
Photo 1 of 1 : FA_2016_RD1001_38_7_20160906_00007.jpg

LM Start	8.57	Rating **	M	Issue No.	7
LM End	8.97	Issue Type +	Ma	Location *	WS
Category	Supplemental			GPS Latitude/Longitude	
				Start	End
Item	2015 USACE Erosion Survey, DRAFT			38.836966 °	38.831498 °
				-121.634128 °	-121.636371 °
DWR ID	DWR_RD1001_04_s_2016_7				
Comment Code					
Inspector Comment					
2006 - Sandy, silty bank with intermittent pockets of erosion. Rotational failure and tree pop outs are most of the problem. Some upper slope fluvial erosion. 2010 - Site extended upstream. The lower Feather may benefit from a regional repair. 2011 - Site combined with 3.6. Minimal new erosion. 2013 - New erosion observed at bank toe. Trees on site now have exposed roots. 2015: No observed changes. [2015 Site ID: FHR_3-8_L]

USACE 2013 Photo #1

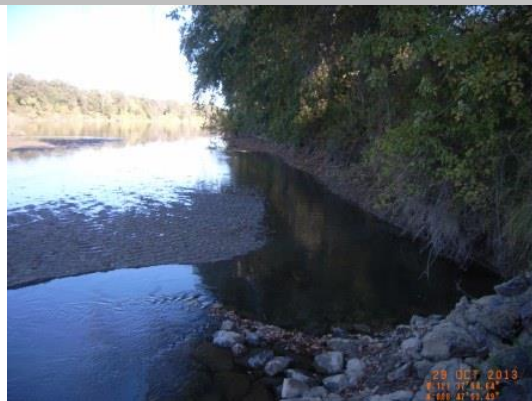
Photo 1 of 1 : FA_2016_RD1001_38_6_20160906_00006.jpg

LM Start	11.18	Rating **	M	Issue No.	6
LM End	11.37	Issue Type +	Ma	Location *	WS
Category	Supplemental			GPS Latitude/Longitude	
				Start	End
Item	2015 USACE Erosion Survey, DRAFT			38.800920 °	38.798165 °
				-121.633050 °	-121.631939 °
DWR ID	DWR_RD1001_04_s_2016_6				
Comment Code					
Inspector Comment					
2000 - Site is relatively stable except for some toe erosion at the upstream end, recommend monitoring the upstream end. 2004 - Some new block failures (10ft deep) at the toe of the upstream end. 2007 - Some minor new slumping at the waterline. 2013 - Minor new erosion along the bank toe. 2015: No observed changes. [2015 Site ID: FHR_1-0_L]

USACE 2013 Photo #1

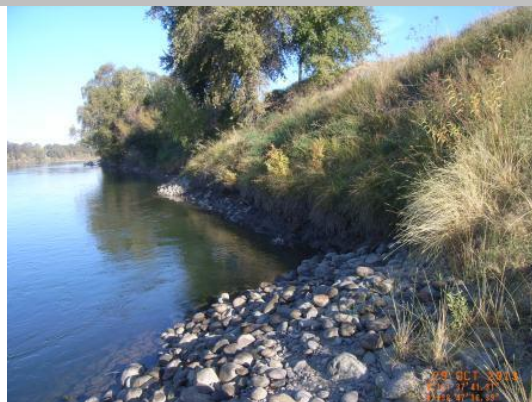
Photo 1 of 1 : FA_2016_RD1001_38_1_20160906_00001.jpg

LM Start	11.59	Rating **	M	Issue No.	1
LM End	11.75	Issue Type +	Ma	Location *	WS
Category	Supplemental			GPS Latitude/Longitude	
				Start	End
Item	2015 USACE Erosion Survey, DRAFT			38.795455 °	38.793394 °
				-121.629903 °	-121.628156 °
DWR ID	DWR_RD1001_04_s_2016_1				
Comment Code					
Inspector Comment					
1997- Deposits over top of cobble on the upper slope. 2000 - Old cobble site in poor shape; some toe retreat, but little change; steep bank. 2010 - Site extended upstream due to new toe erosion. 2012 - Minor new erosion at toe, new slumping, animals holes and cracks observed. 2015: No observed changes. [2015 Site ID: FHR_0-6_L]

USACE 2013 Photo #1
